THE STATES OF DELIBERATION
of the
ISLAND OF GUERNSEY

COMMITTEE *FOR THE* ENVIRONMENT & INFRASTRUCTURE

PROPOSALS FOR THE PARTIAL REMOVAL OF THE ANTI-TANK WALL IN THE EASTERN
PART OF PEMBROKE BAY (L'ANCRESSE EAST) AND THE MANAGED RE-ALIGNMENT OF
THE COASTLINE IN THIS AREA

**PROPOSALS FOR THE PARTIAL REMOVAL OF THE ANTI-TANK WALL IN THE EASTERN
PART OF L'ANCRESSE BAY AND THE MANAGED RE-ALIGNMENT OF THE COASTLINE IN
THIS AREA**

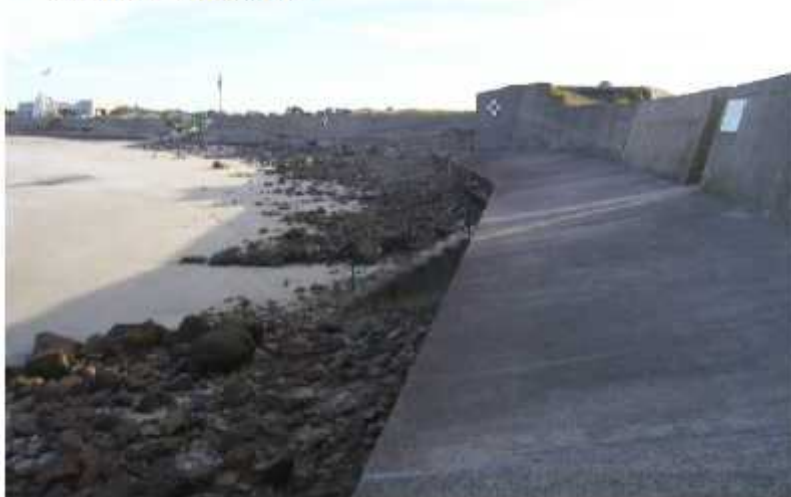
Plate 6.11. Build up of shingle at the southern end of DU2

Considering the angle of wave approach in this corner, it may be appreciated that waves locally at the slipway are significantly out of line with the curve of the wall. Even further east, towards the western kiosk, waves are shown to be approach the wall slightly from the west of north. This contributes to the trend of erosion causing a slow drift to the east.

Records show that the toe to this section of defence is regularly undermined and requires regular repair. This is consistent with the interaction with waves in the area. It may be concluded that the general alignment of the defence is too far forward and would be subjected to regular periods of erosion and a continuing need for management. With sea level rise this problem will become worse. The area is one of the most vulnerable sections of the frontage and is critical to the longer term flood risk management to the local area behind.

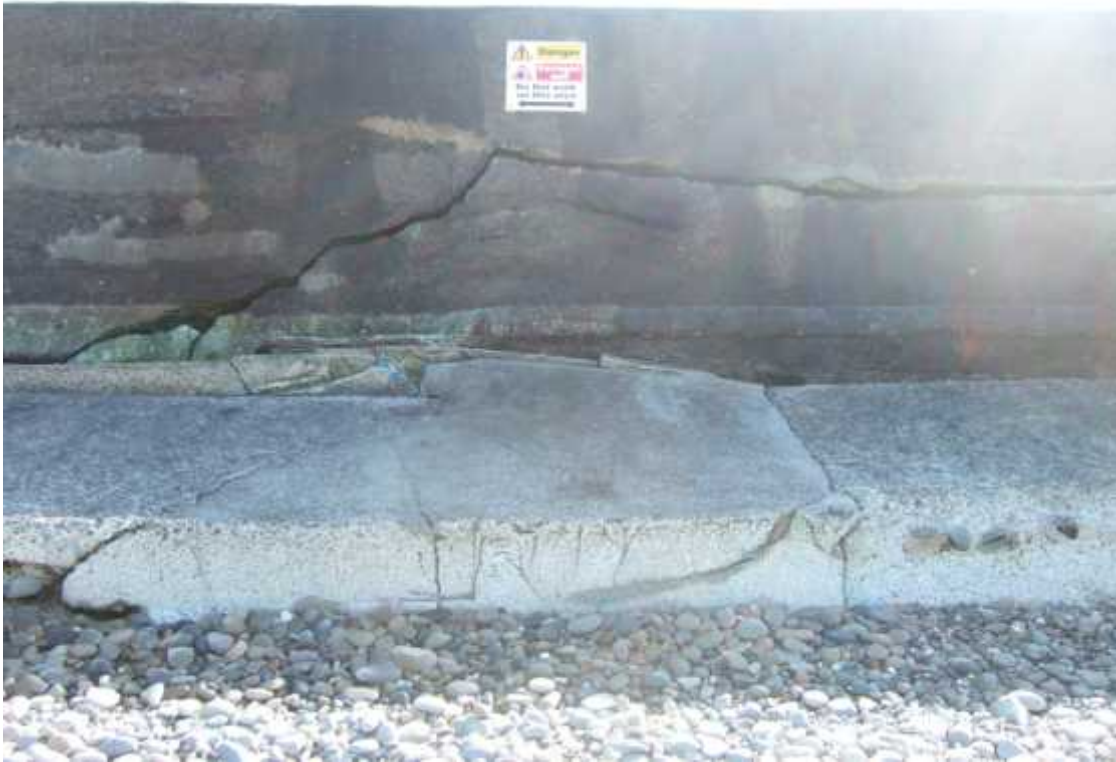
Panel 5, 25 March 2015

The photo timeline series below illustrates how a crack in the wall can develop over time, and does not increase in size in a linear fashion; rather there can be periods of little change followed by a short-term significant change. The cause of these cracks is continued undermining of the wall leading to the large gaps beneath, into which the wall is rotating.

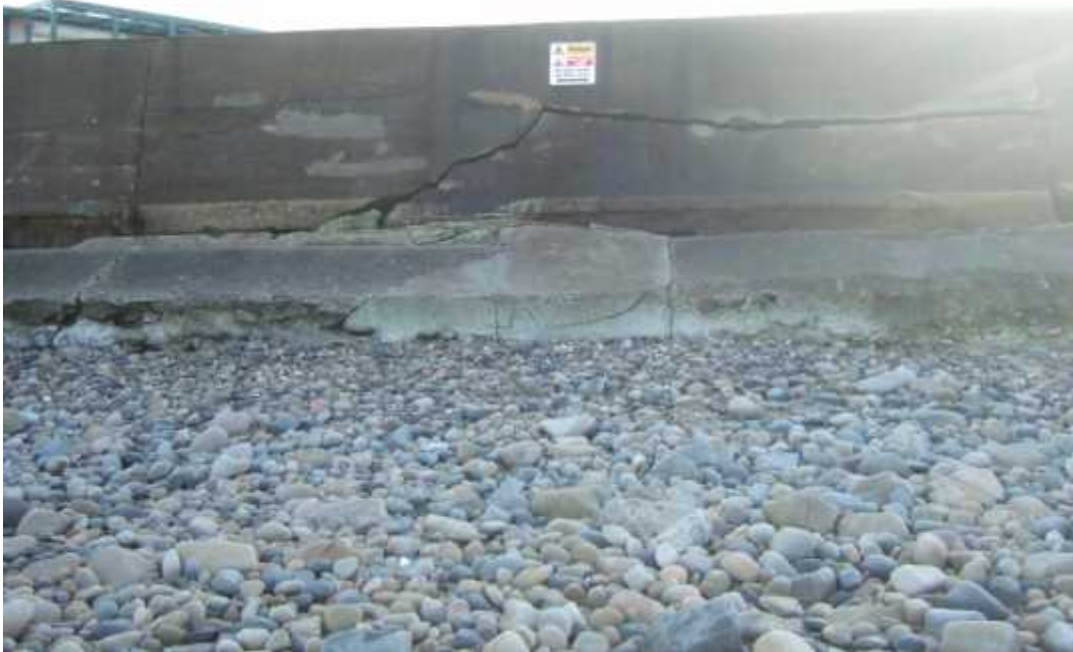
Panel 5, 19 January 2016

There was little change between March 2015 and January 2016

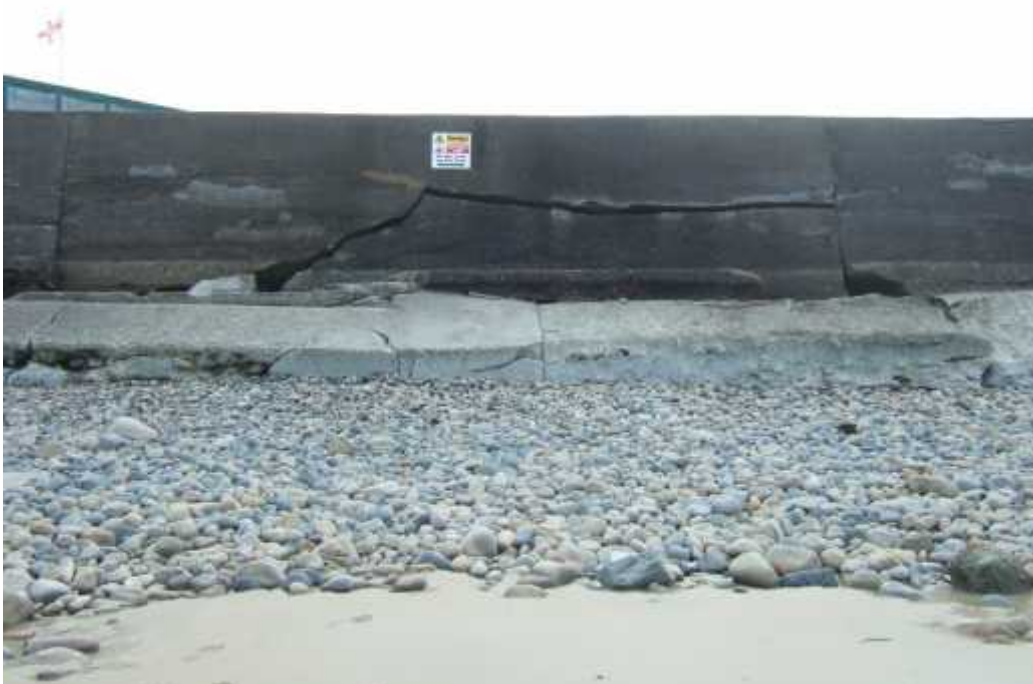
Panel 5, 27 April 2016

Between March 2016 and April 2016 there is an obvious increase in the crack in the wall.

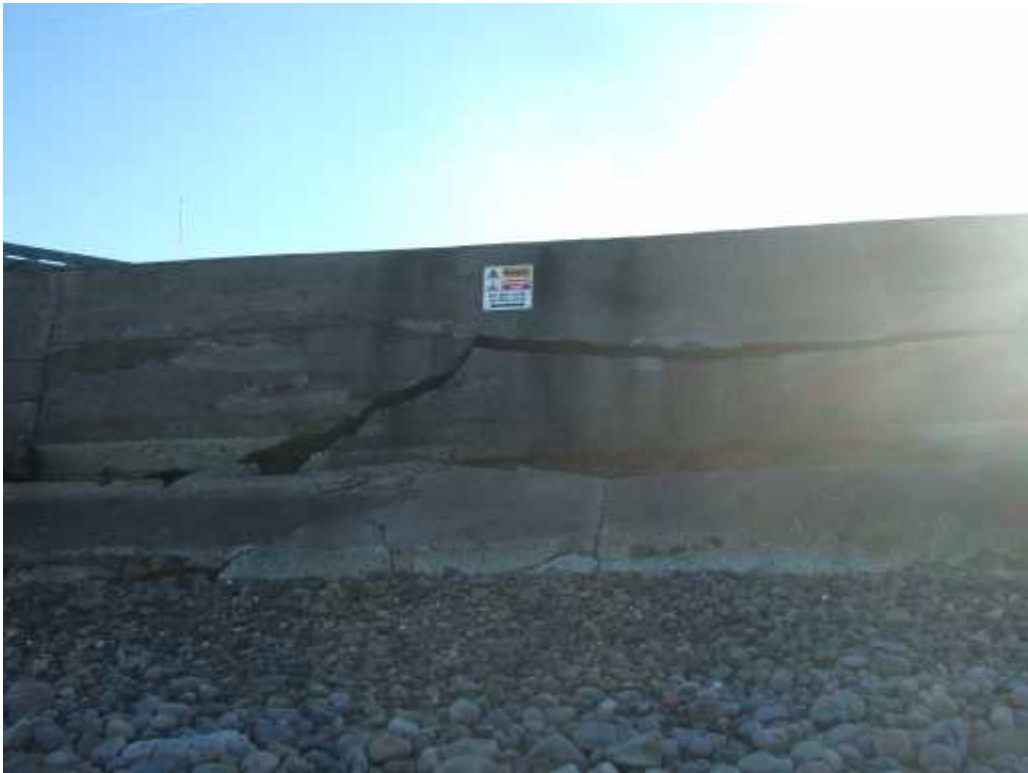
Panel 5, 6 February 2017

While less obvious, the crack continued to increase in size between April 2016 and February 2017.

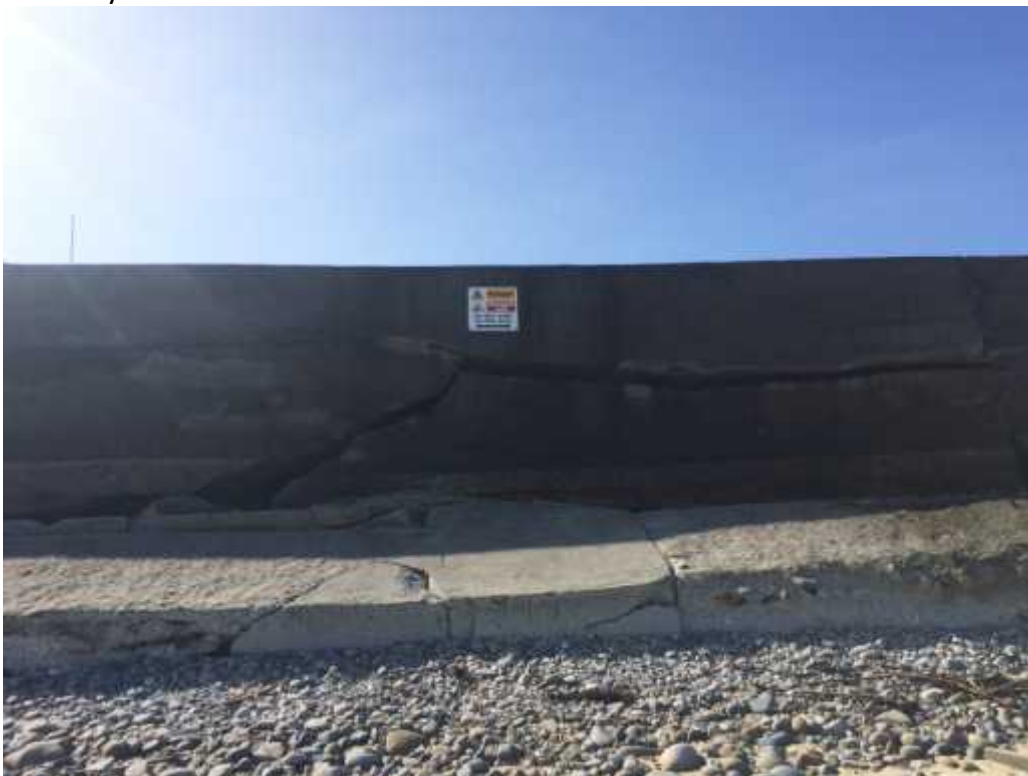
Panel 5, 5 April 2017

A small further increase in the main crack was again evident, but additional separation along the smaller crack along the upper third of the wall was noticeable. It was also at this point obvious that the crack extended throughout the all with material being lost from behind.

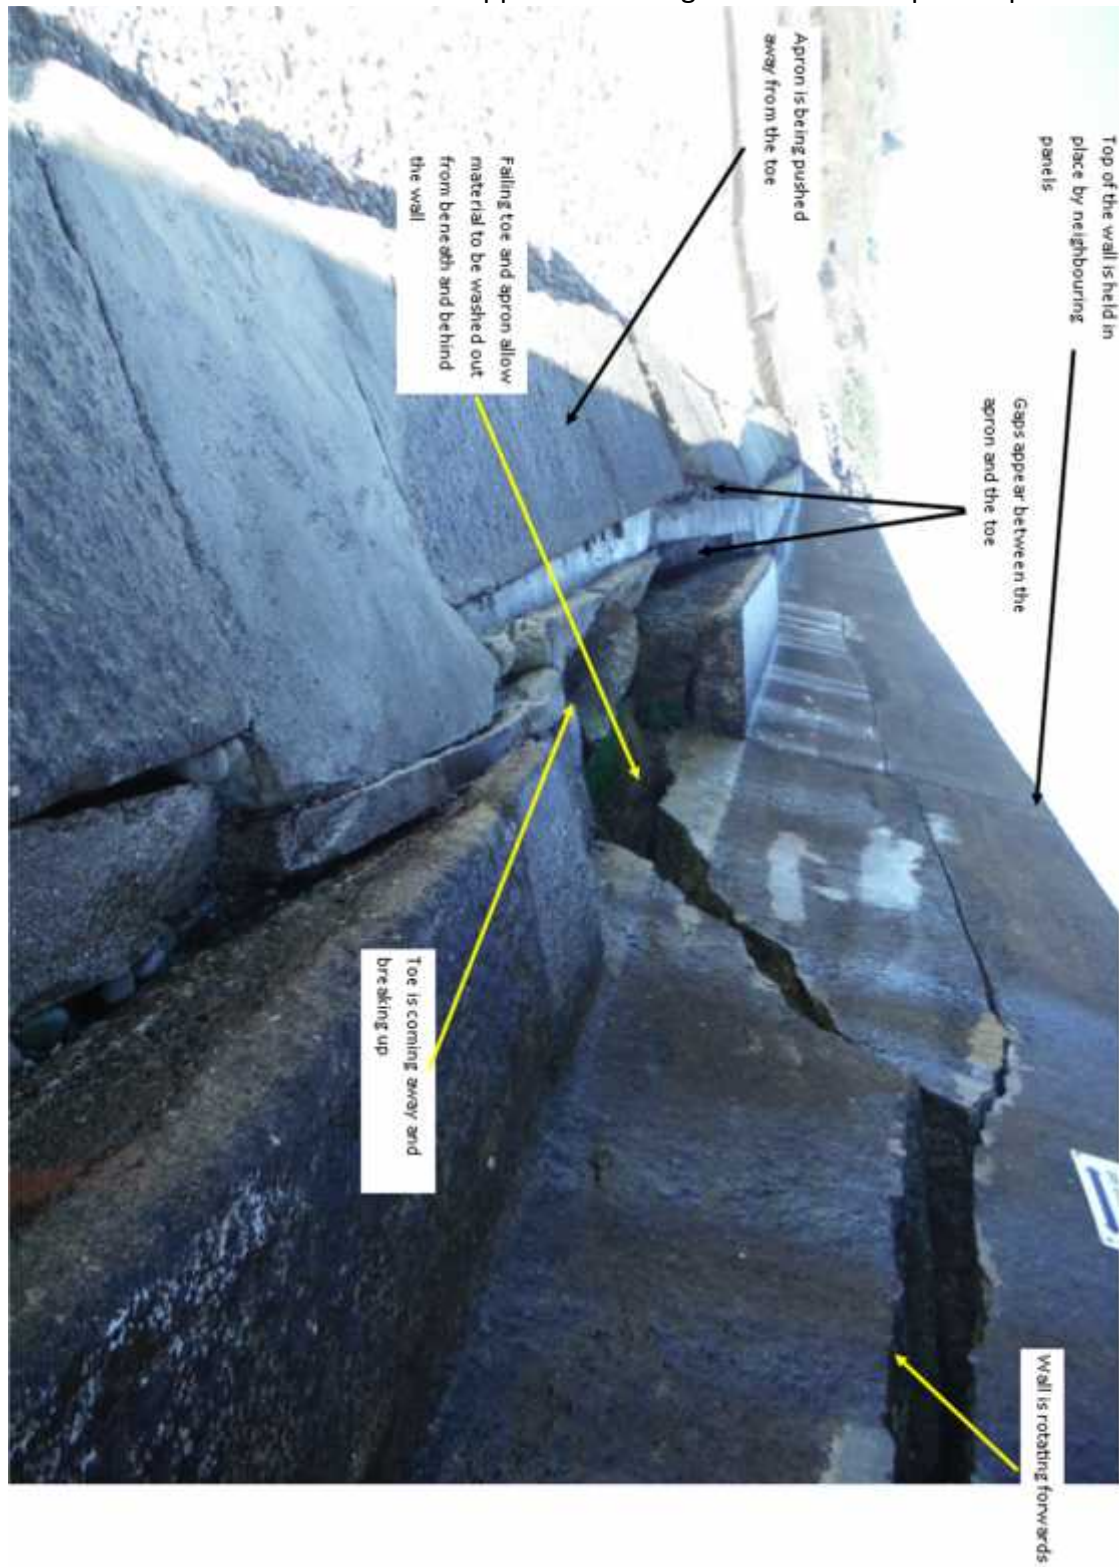
Appendix 7 – diagram of toe and apron separation.

- 5.6 A series of concrete aprons were constructed at the base of the wall around the toe in the 1960s and a series of repairs were made over subsequent decades. However, these have not been successful at the eastern end. The wall's rotation forward has pushed the apron sections away from the base and has caused them to crack longitudinally (see Appendix 7).
