L'Ancrese Bay

Discussion of Future Management

Gregor Guthrie,
22 August 2017

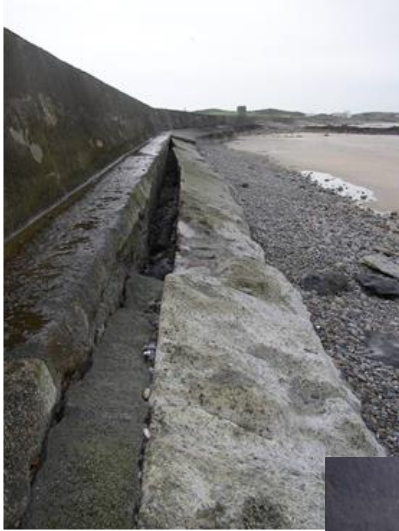
Toe falling
away from
the wall

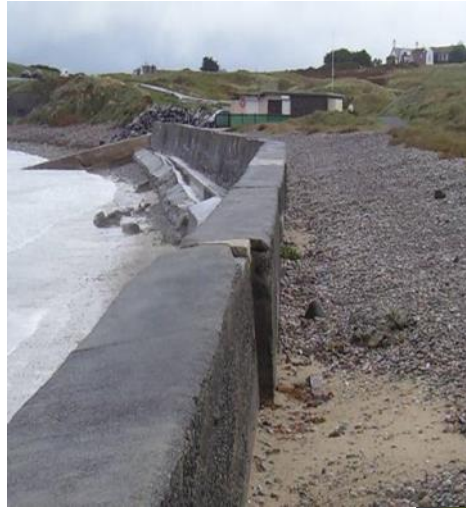
Wall moving

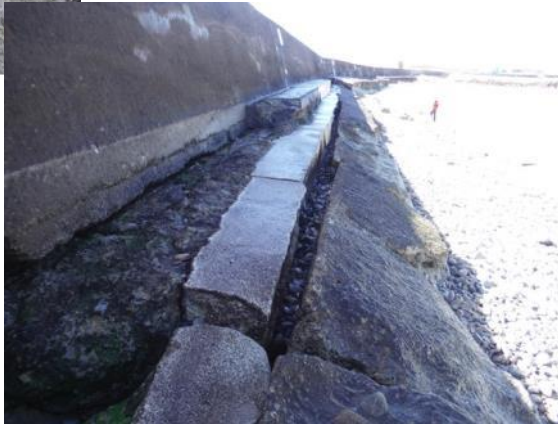
Repair work
being
undermined

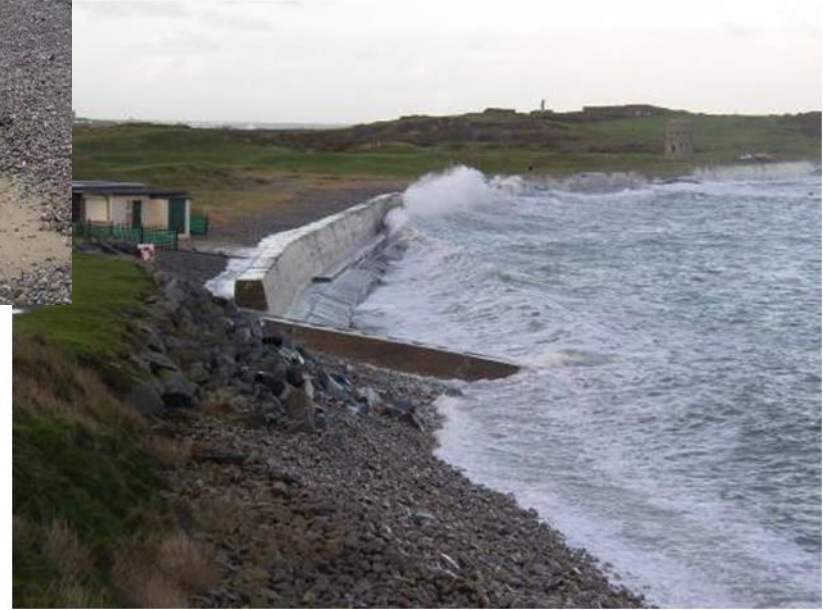
Wave action
causing scour

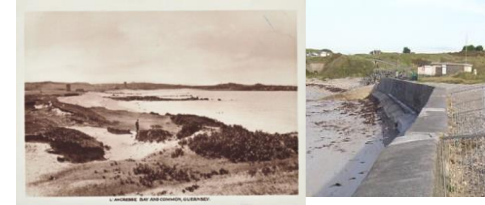
Without the wall:

- The natural coastline might have set back some 30m
- The road to the carpark would have been set back
- The kiosk would not have been built where it has been built

--- 1898 charted mean high water mark
--- 1938 charted mean high water mark
--- 2017 predicted mean high water mark in absence of the wall

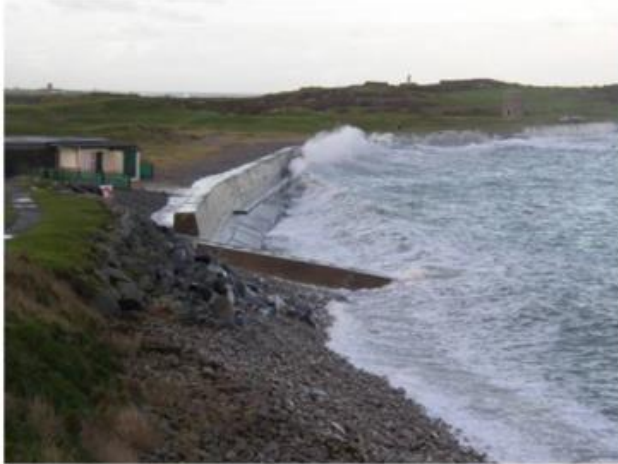
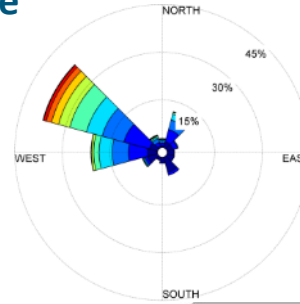
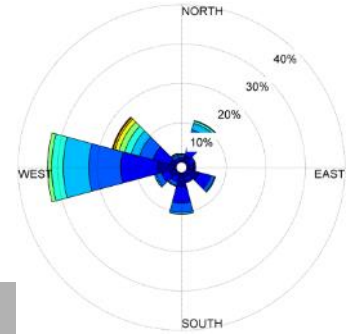
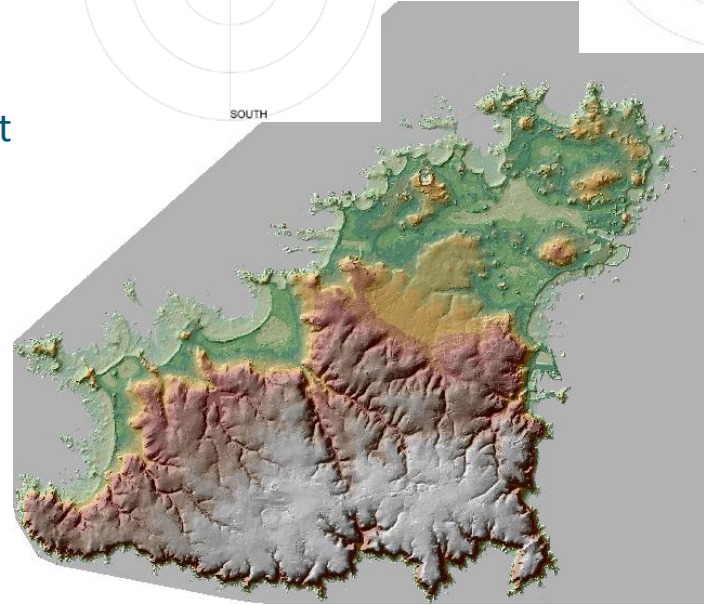
Analysis of the bay – Island Wave Rose Analysis

The length of each coloured spoke in the **directional wave roses** shown relate to the percentage of time that the waves arrive from that particular direction. Each concentric circle represents a different frequency, emanating from zero at the centre to increasing frequencies at the outer circles. Each spoke is broken down into colour-coded bands that show wave height ranges.

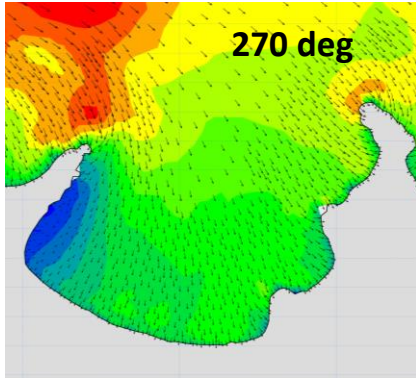
Western and middle sections of the bay have lower wave action.

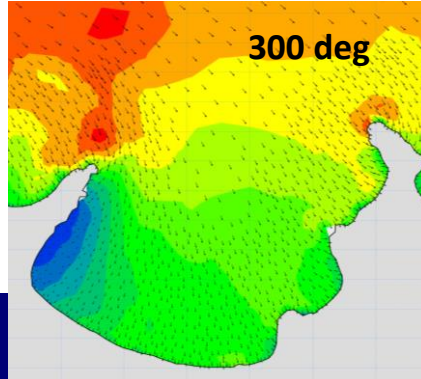
Western end of the bay has lower wave action.

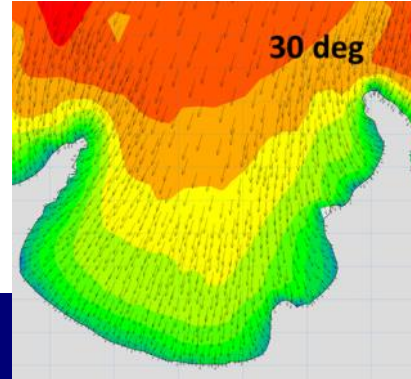
Bay has more even wave action – still higher at eastern end.

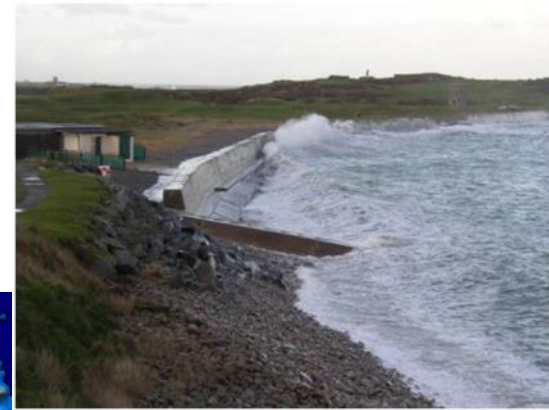
Waves travel along the wall to the eastern end

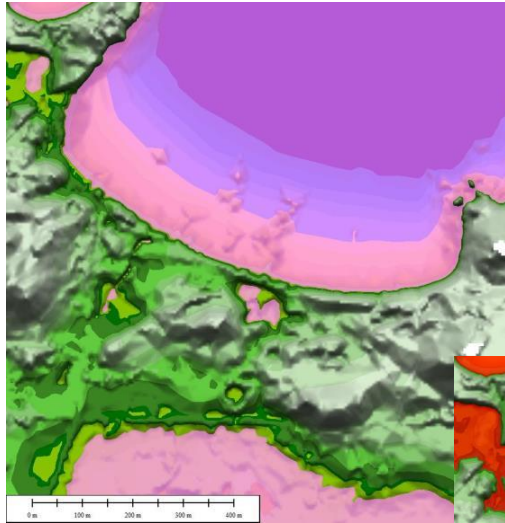
1 in 50 year Storm flood event – no route through to flood plain (natural highland prevents flooding)

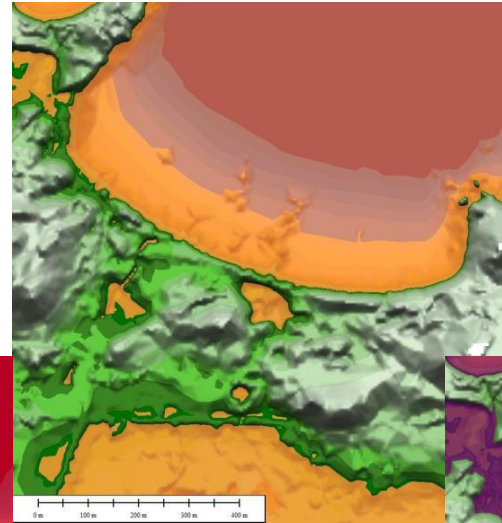
1 in 100 year storm flood event – no route through to flood plain (natural highland prevents flooding)

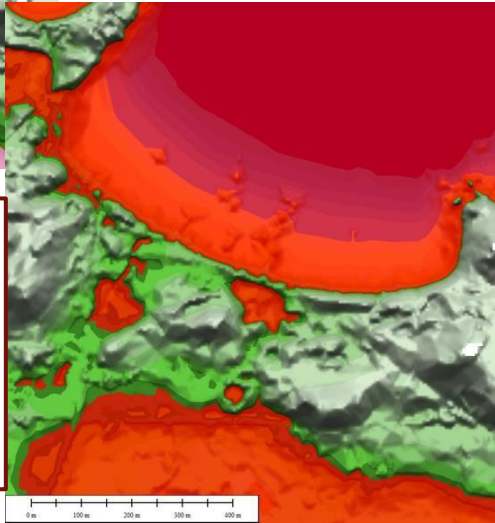
1 in 100 year storm flood event + 0.5m sea level rise – no route through to flood plain (natural highland prevents flooding)

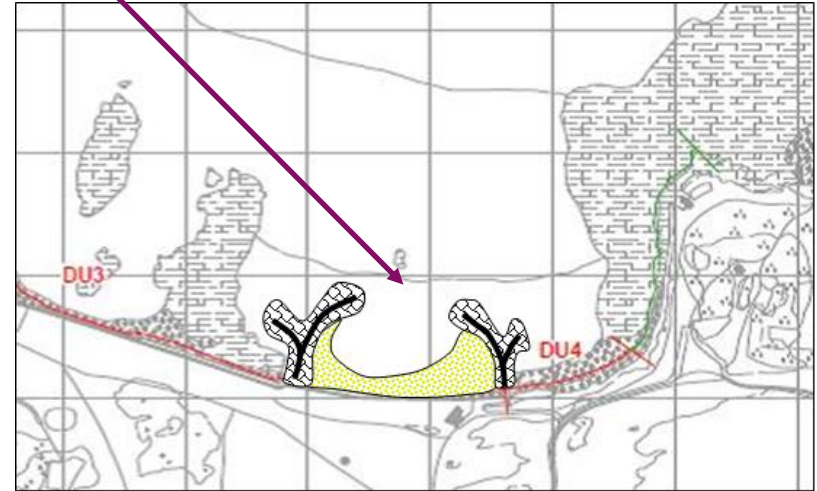
4. Modify beach behaviour – creation of a sub-bay

- Improves beach use
- Builds beach in front of the wall
- Potential to provide 50 years defence.

This option looks to address the fundamental problem of lack of width

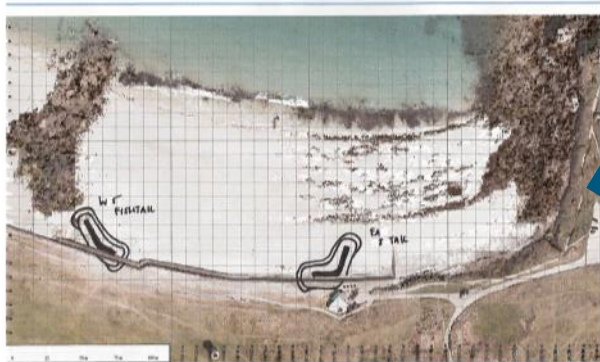
5. Creation of width – Managed realignment

- Limiting erosion
- Protection to slipway and eastern wall.
- Maintaining integrity of the western wall
- Enhanced amenity

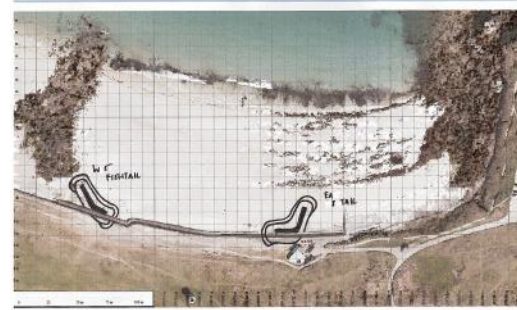
- Spacing of structures determines erosion line
- Structures support the western wall
- Structures offer protection to the slipway
- Facilitates development of a beach and dune habitat

— lower projection of erosion
— higher projection of erosion
