Chouet Headland Development Framework

Appendix 2

Supplementary Planning Guidance October 2021

Appendix 2: Research required as part of the Environmental Impact Assessment

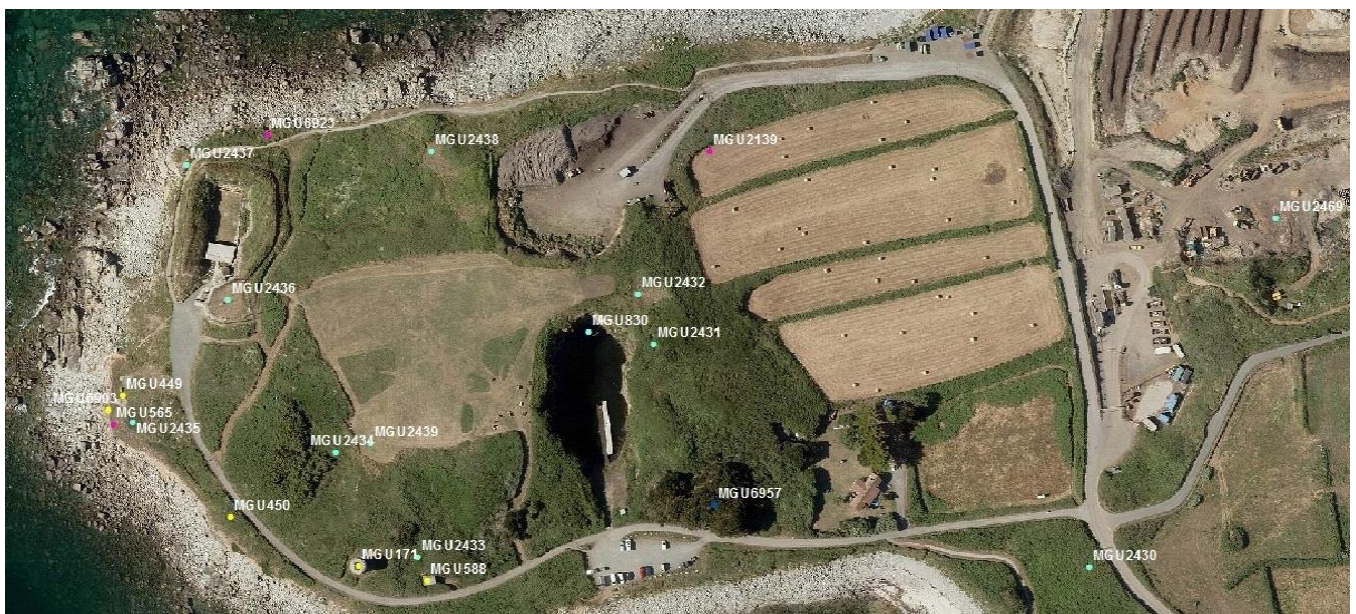
Figure 3-1
List of sites present on the States of Guernsey's Historic Environment Record (HER)

Despite historic and recent quarrying activity, the archaeology and cultural heritage in and surround the Chouet Headland is extensive. Many sites, including Registered Buildings and Registered Sites, are mainly within the foreshore zone, with eight sites located within the core of the Headland (Figure 3-1). Many of the sites are considered industrial, associated with recent former quarrying industry (Figure 3-2). Immediately east of the quarrying is a linear field system, constructed of five rectangular east-west plots.

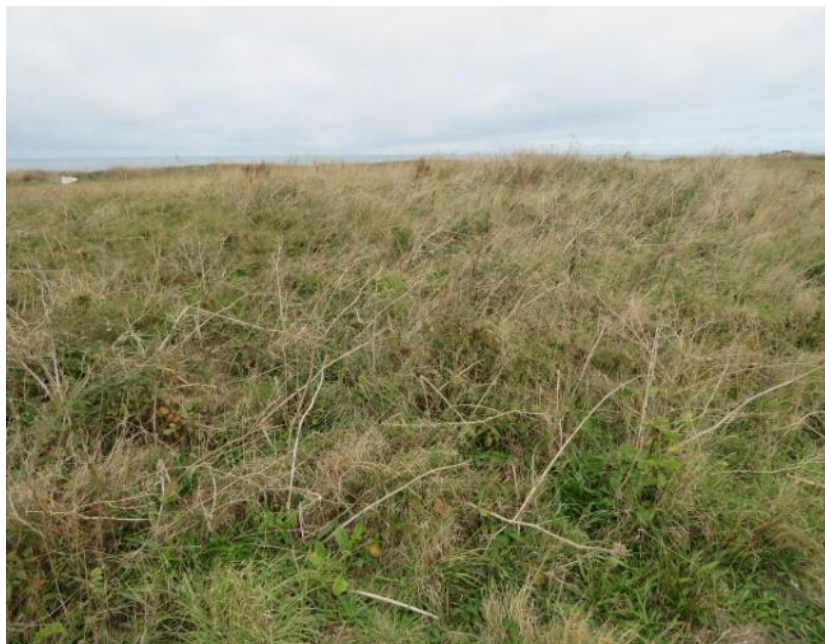
Figure 4-4
Unmanaged area of Semi-Improved Grassland

- i. The patches of Semi-Improved Grassland on the plateau have become rank through lack of regular management (Figure 4-4).

The habitats as mapped in 2017 have remained largely unchanged over the last three years. There has been a negligible loss of Semi-Improved Grassland and a lack of recent management in some locations has led to a downturn in overall condition, mostly on the plateau and within the grounds of the house.

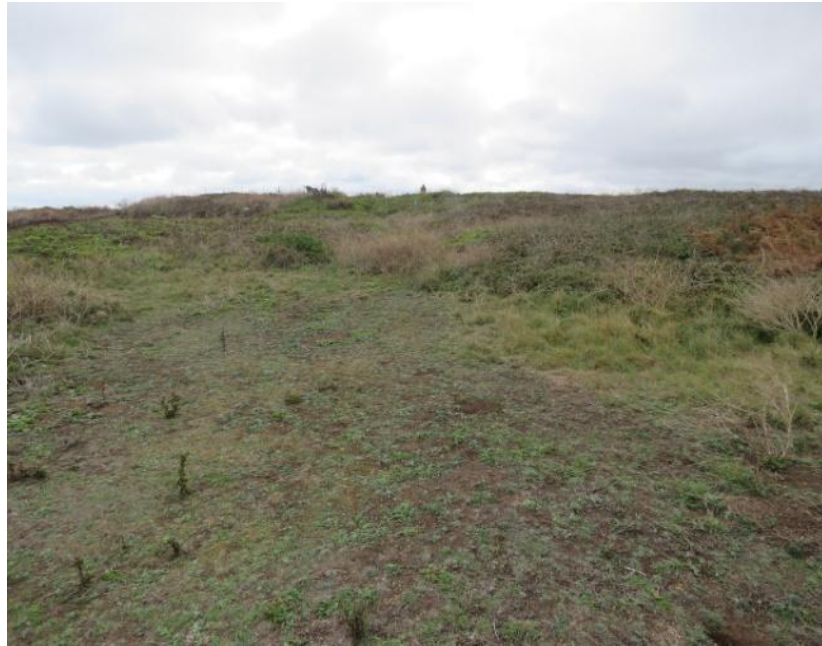
Figure 4-5
Remnant of Semi-Improved Grassland

- ii. The fragment of Semi-Improved Grassland within Bramble Scrub to the west of the Green Tip has decreased in size by around 50% due to encroachment (Figure 4-5).

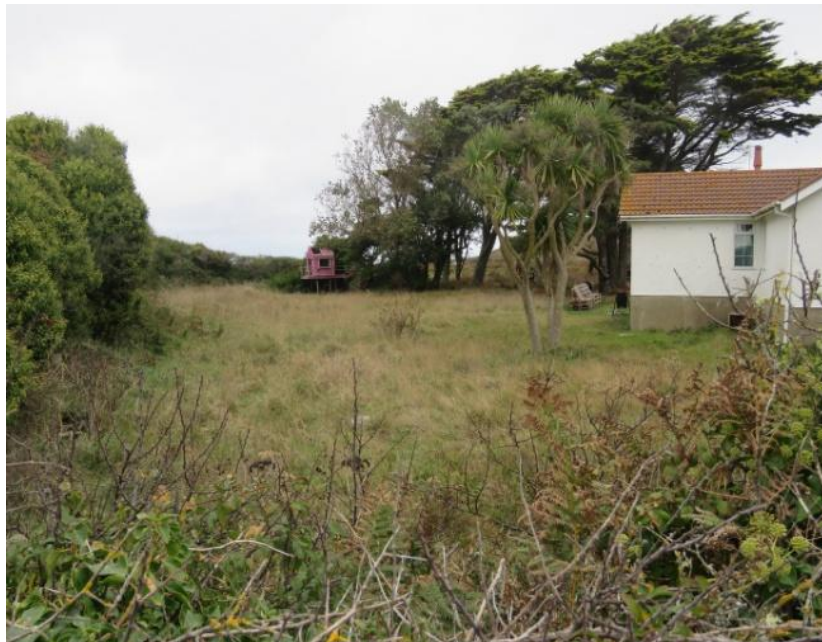
Figure 4-6
Unmaintained grounds of the house

- iii. The domestic curtilage of the house had not been maintained recently and the lawned areas had become rank (Figure 4-6).

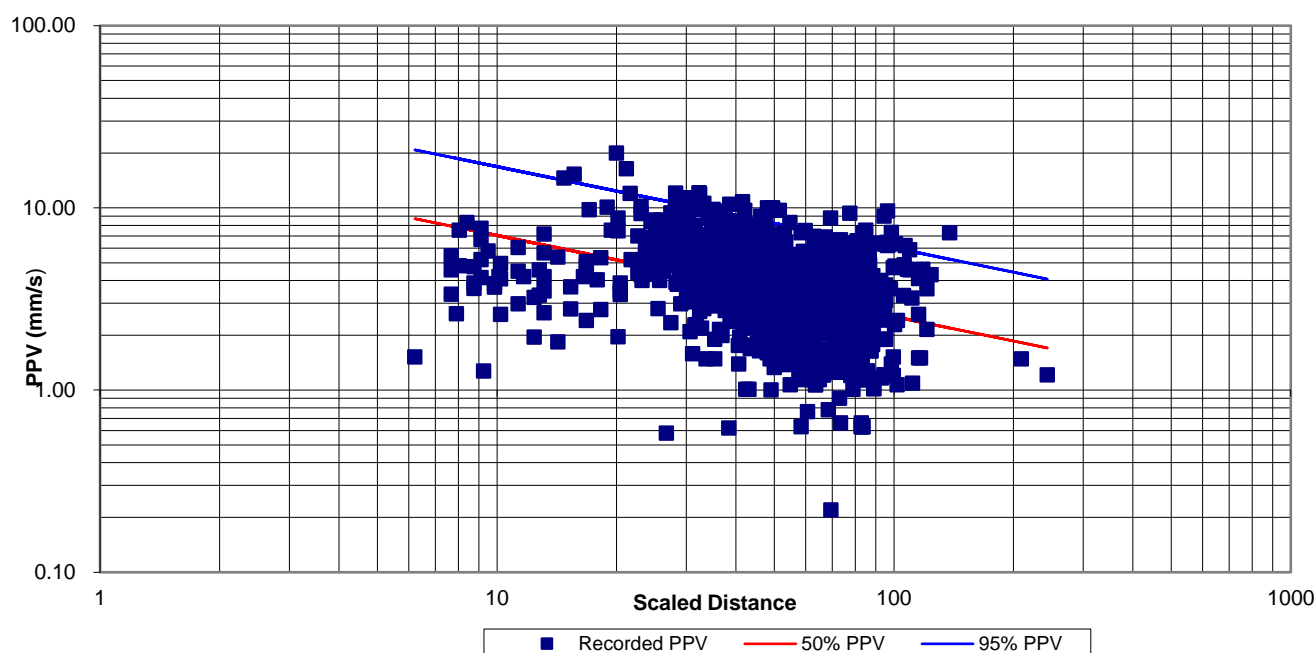
Figure 8-1
Blasting Regression Line Model

Analysis of the recorded vibration data from Les Vardes Quarry has been used to create a regression line, showing both the 50% and the 95% confidence limit and is shown in Figure 8-1. The regression line plot shows that the corresponding scaled distance value for a vibration criterion of 10.0mm/s PPV at 95% confidence level is 32.2mkg^{-1/2}.

Table 8-1 shows the allowable maximum instantaneous charge weight to comply with this criterion at given separation distances.

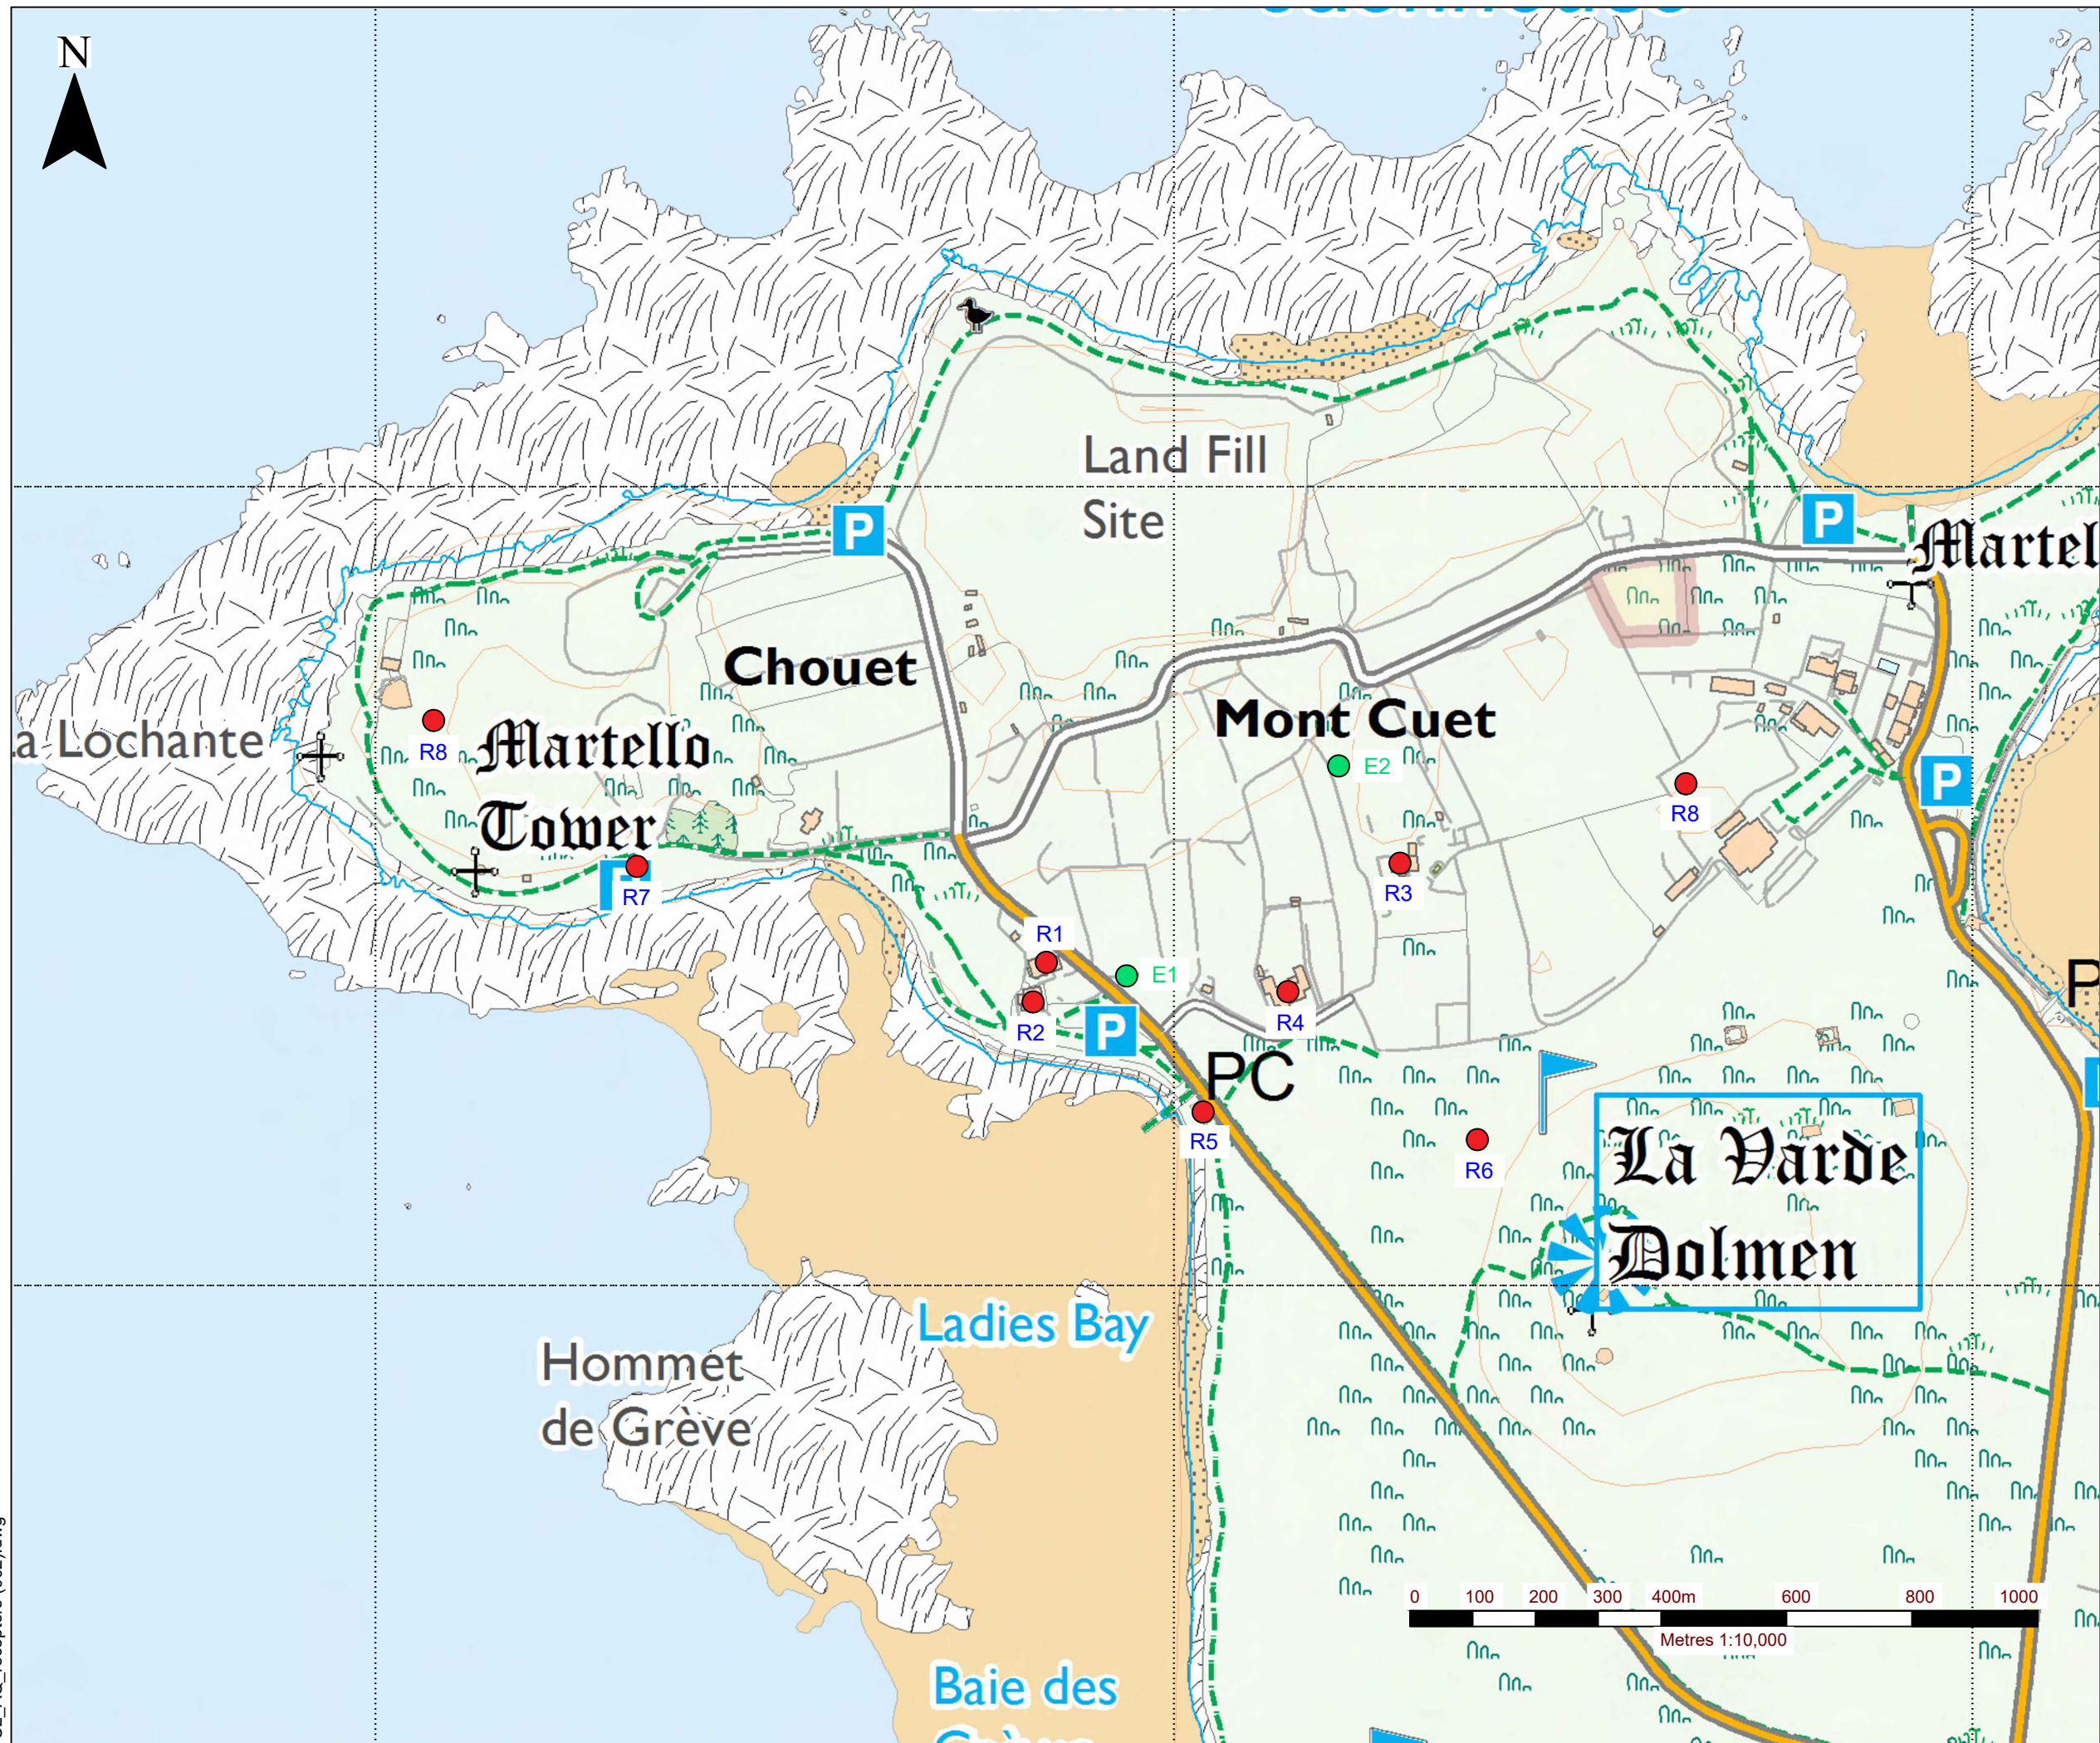
CL_AQ_receptors (002).dwg

The receptors considered in the assessment of dust amenity impacts are presented within Table 2-4 and on **Drawing CH 1**. Where these are referenced within the report text, they are referred to as R1 – R9. It is noted that the residential property within the headland would be demolished as part of the proposals.
